HYGIENETECH

Document No. 21003001.3

Regarding: 21ST Floor Interior Hallway Carpet

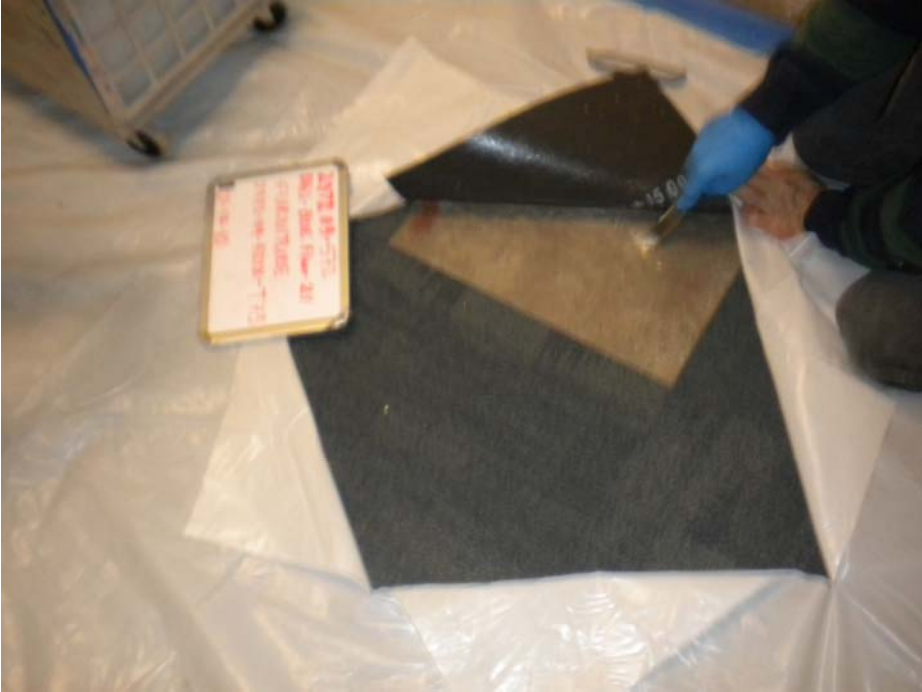
1

Date	Address	Photo Location – Description	Up
01/14/10	450 N Street, Sacramento, California	21 st Floor; hallway; looking down; general view of area; showing reverse side of carpet tile; concrete subfloor and mastic bulk sample collection by LCD personnel	↑

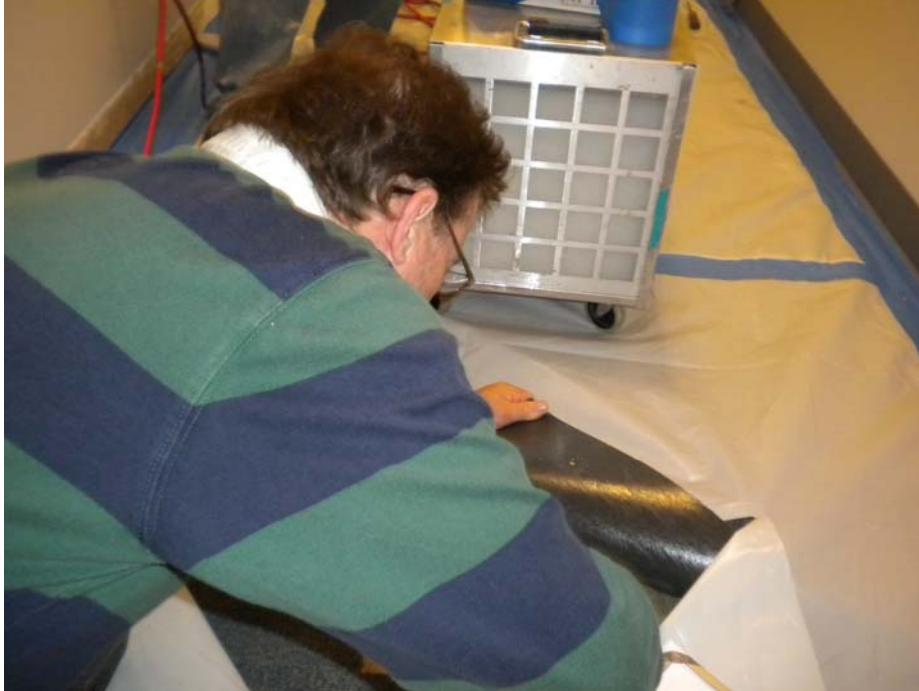
3

Date	Address	Photo Location – Description	Up
01/14/10	450 N Street, Sacramento, California	21 st Floor; hallway; looking down; general view of area; showing reverse side of carpet tile and mastic bulk sample collection by LCD personnel	↑

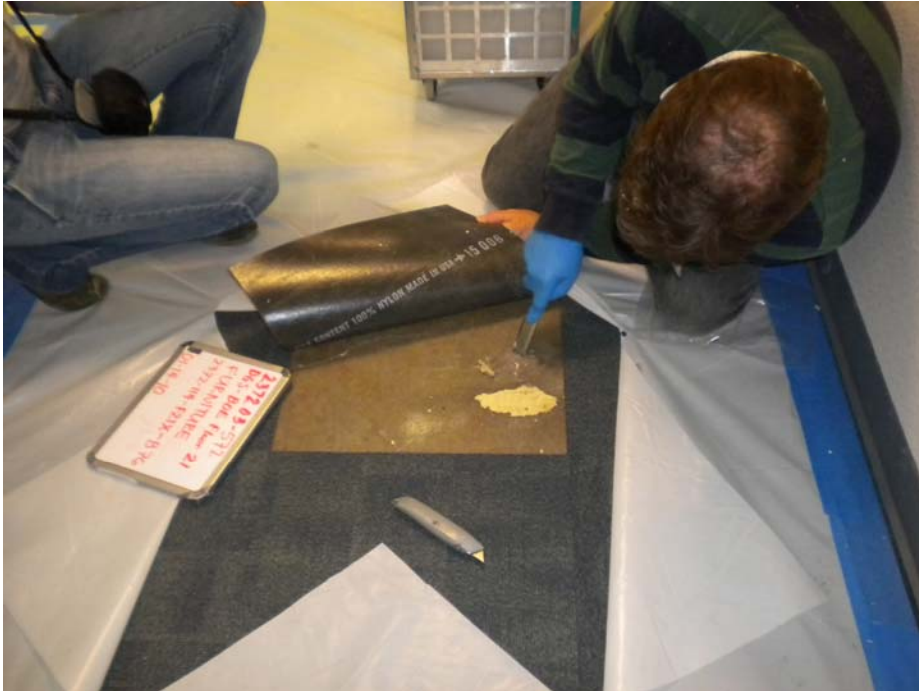
4

Date	Address	Photo Location – Description	Up
01/14/10	450 N Street, Sacramento, California	21 st Floor; hallway; looking down; general view of area; showing reverse side of carpet tile and mastic bulk sample collection by LCD personnel	↑
